City of Alexandria Storm Sewer Capacity Analysis (CASSCA)

Potomac River Condition Assessment

PREPARED BY: Michael Baker Jr., Inc.

DATE: January 12, 2015 (Revised May 26, 2015)

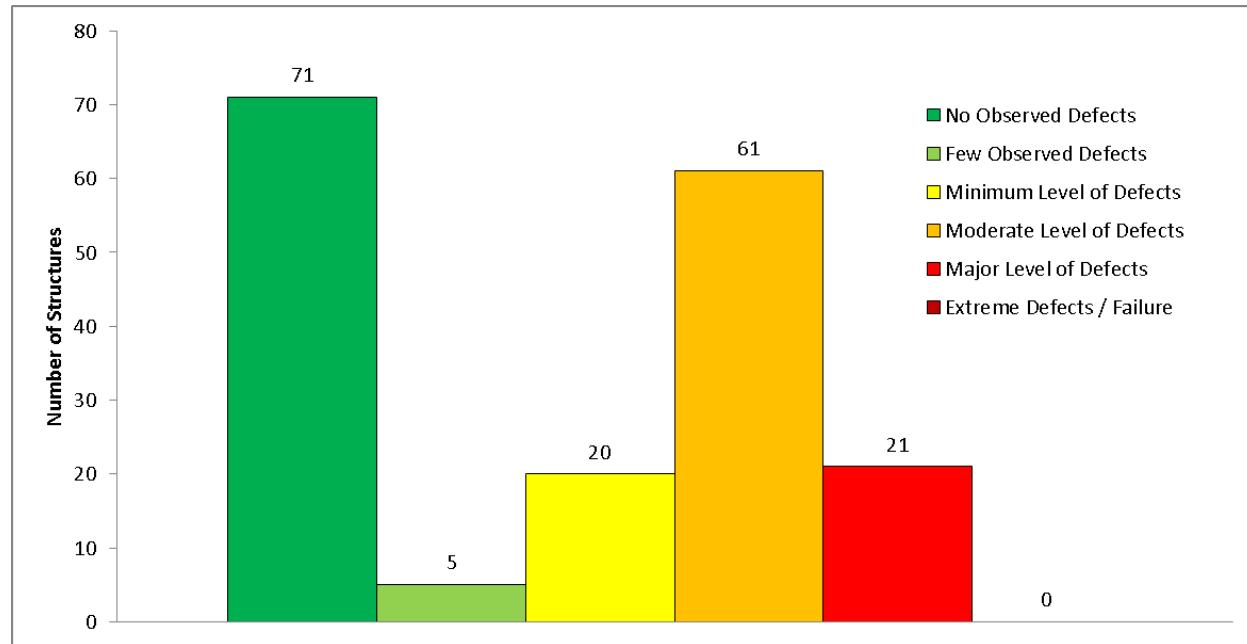
As part of this inspection task, 178 storm structures were inspected in the Potomac River watershed. Figure 1 shows the number of structures within each defect category identified in the previous section. Figure 2 shows the geographic location of each structure within the Potomac River watershed, color coded to its defect category.

The average condition score of the storm structures was 29 (“Minimum” defect category). About 40% of the structures inspected had no observed defects. About 14 percent of the Potomac River structures ranked in the “Few” and “Minimum” defect categories (scores 1-40); approximately 34 percent of the structures had defects in the “Moderate” category; and around 12 percent of the structures had defects in the “Major” category. None of the inspected Potomac River structures are ranked in the “Extreme” category. The highest structure score was 78.

Figure 1. Structure Inspection Summary.

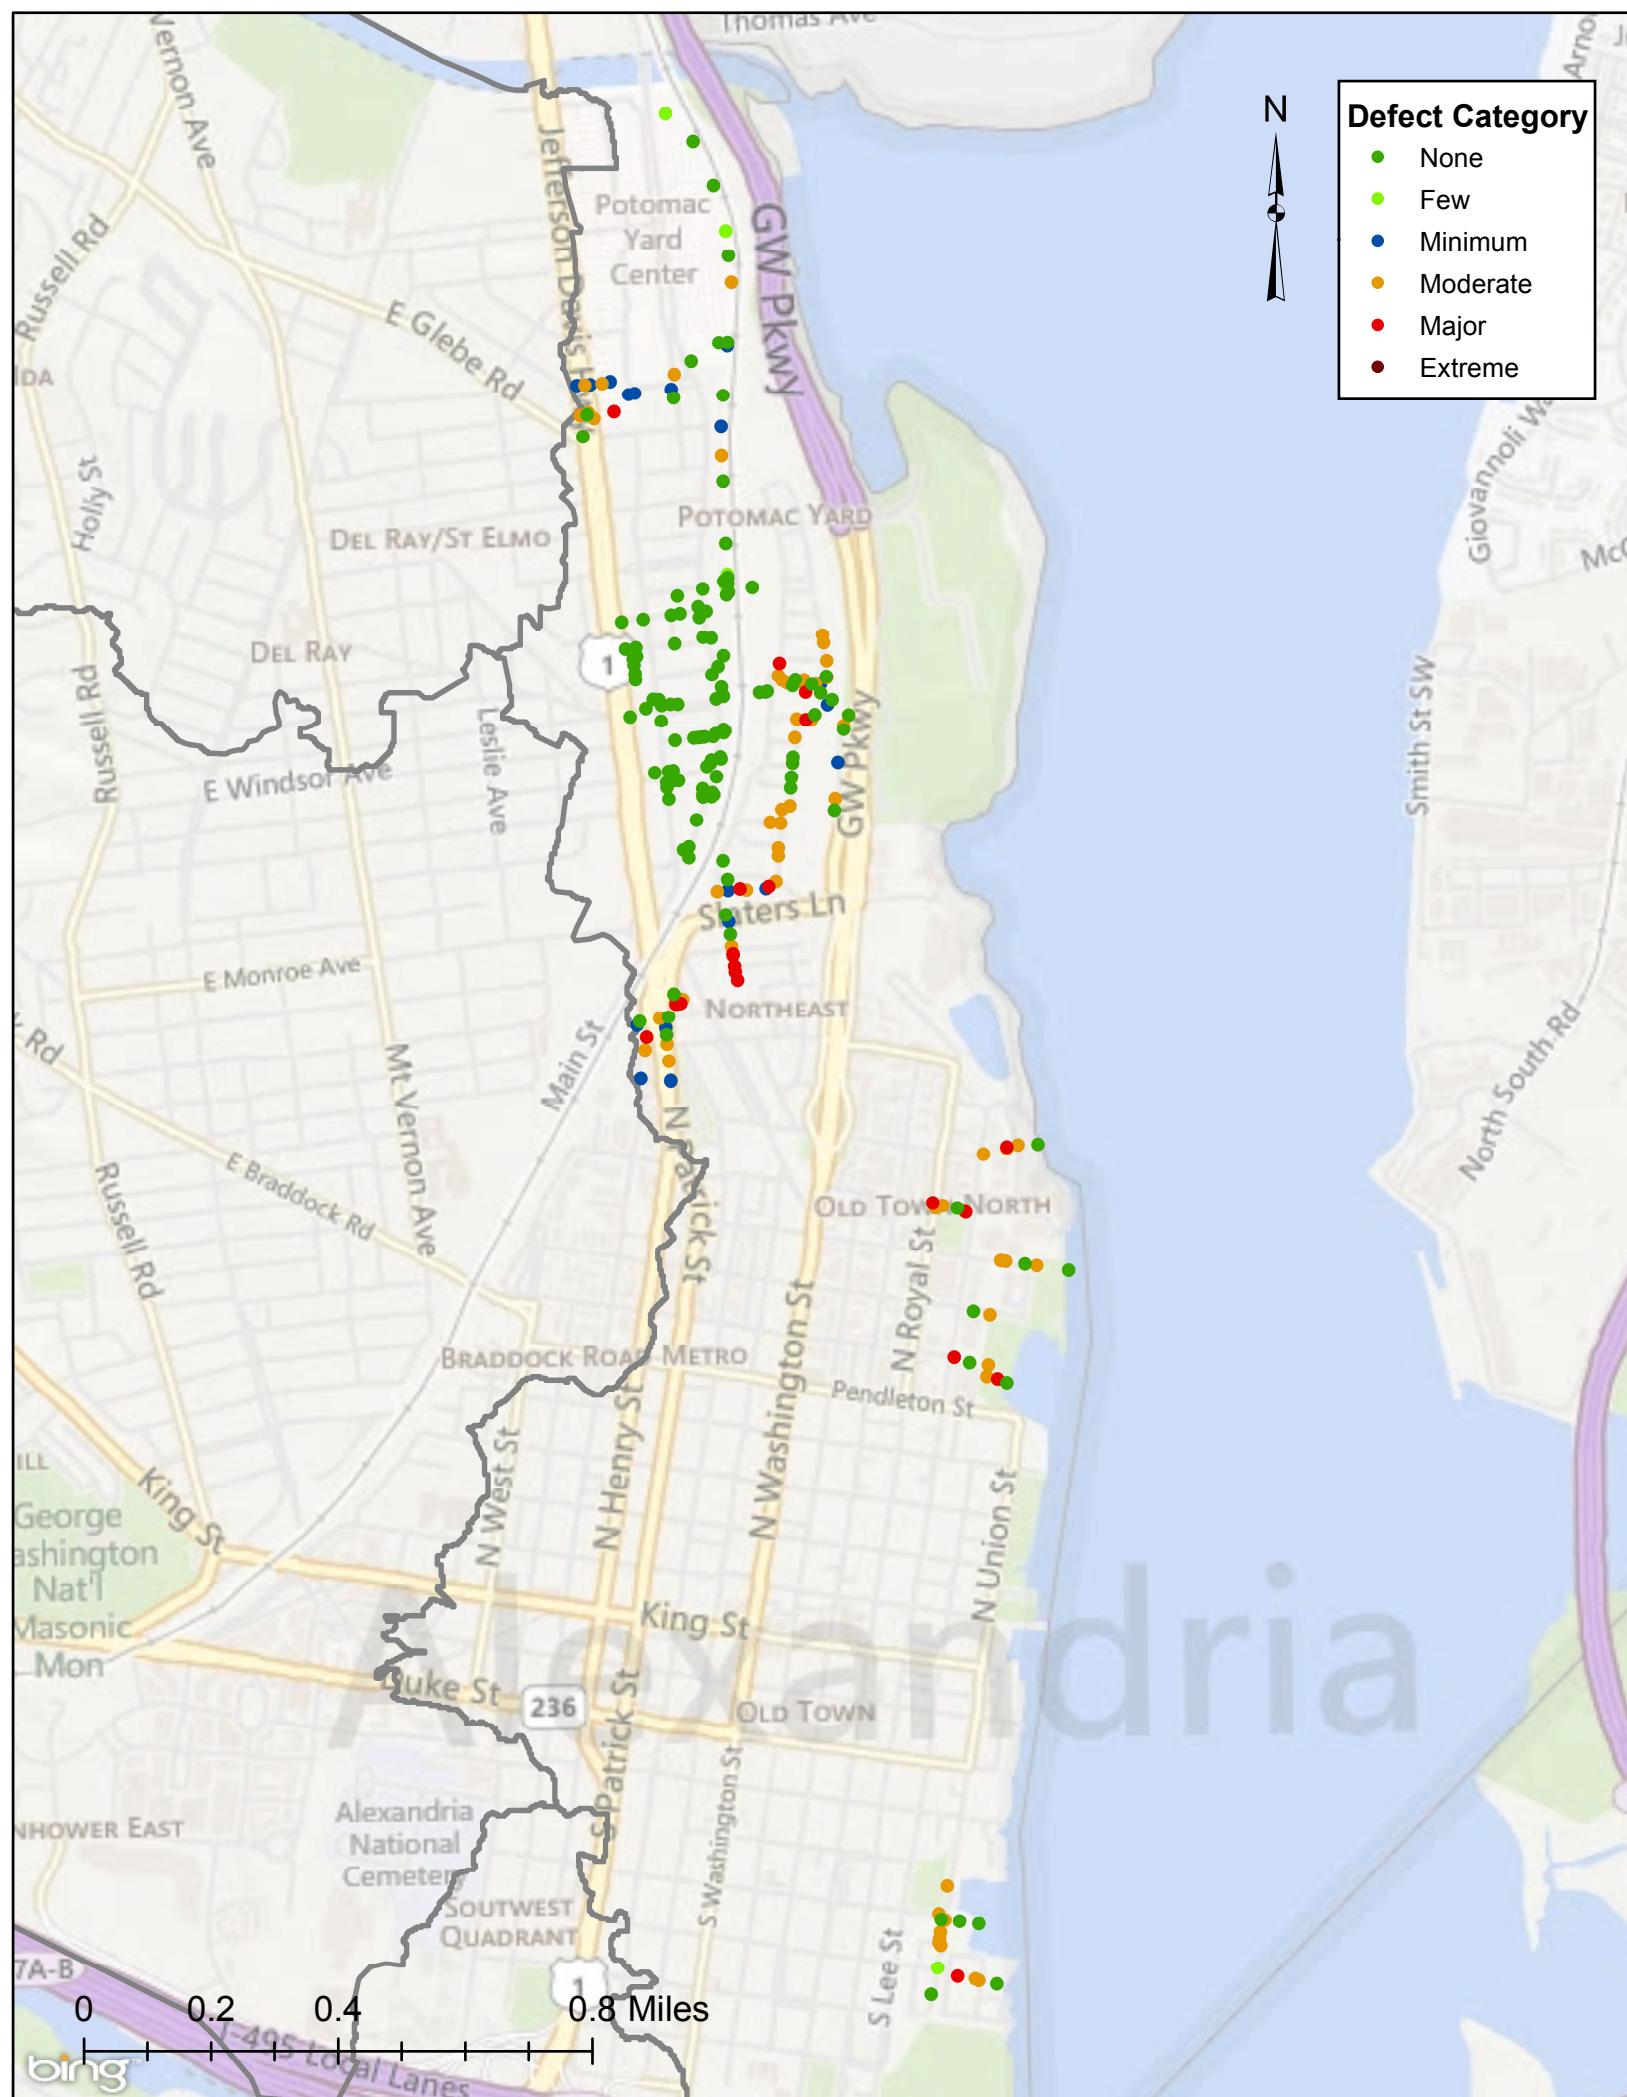
Figure 2. Overall Condition of Storm Structures (Color coded by Severity of Defects).

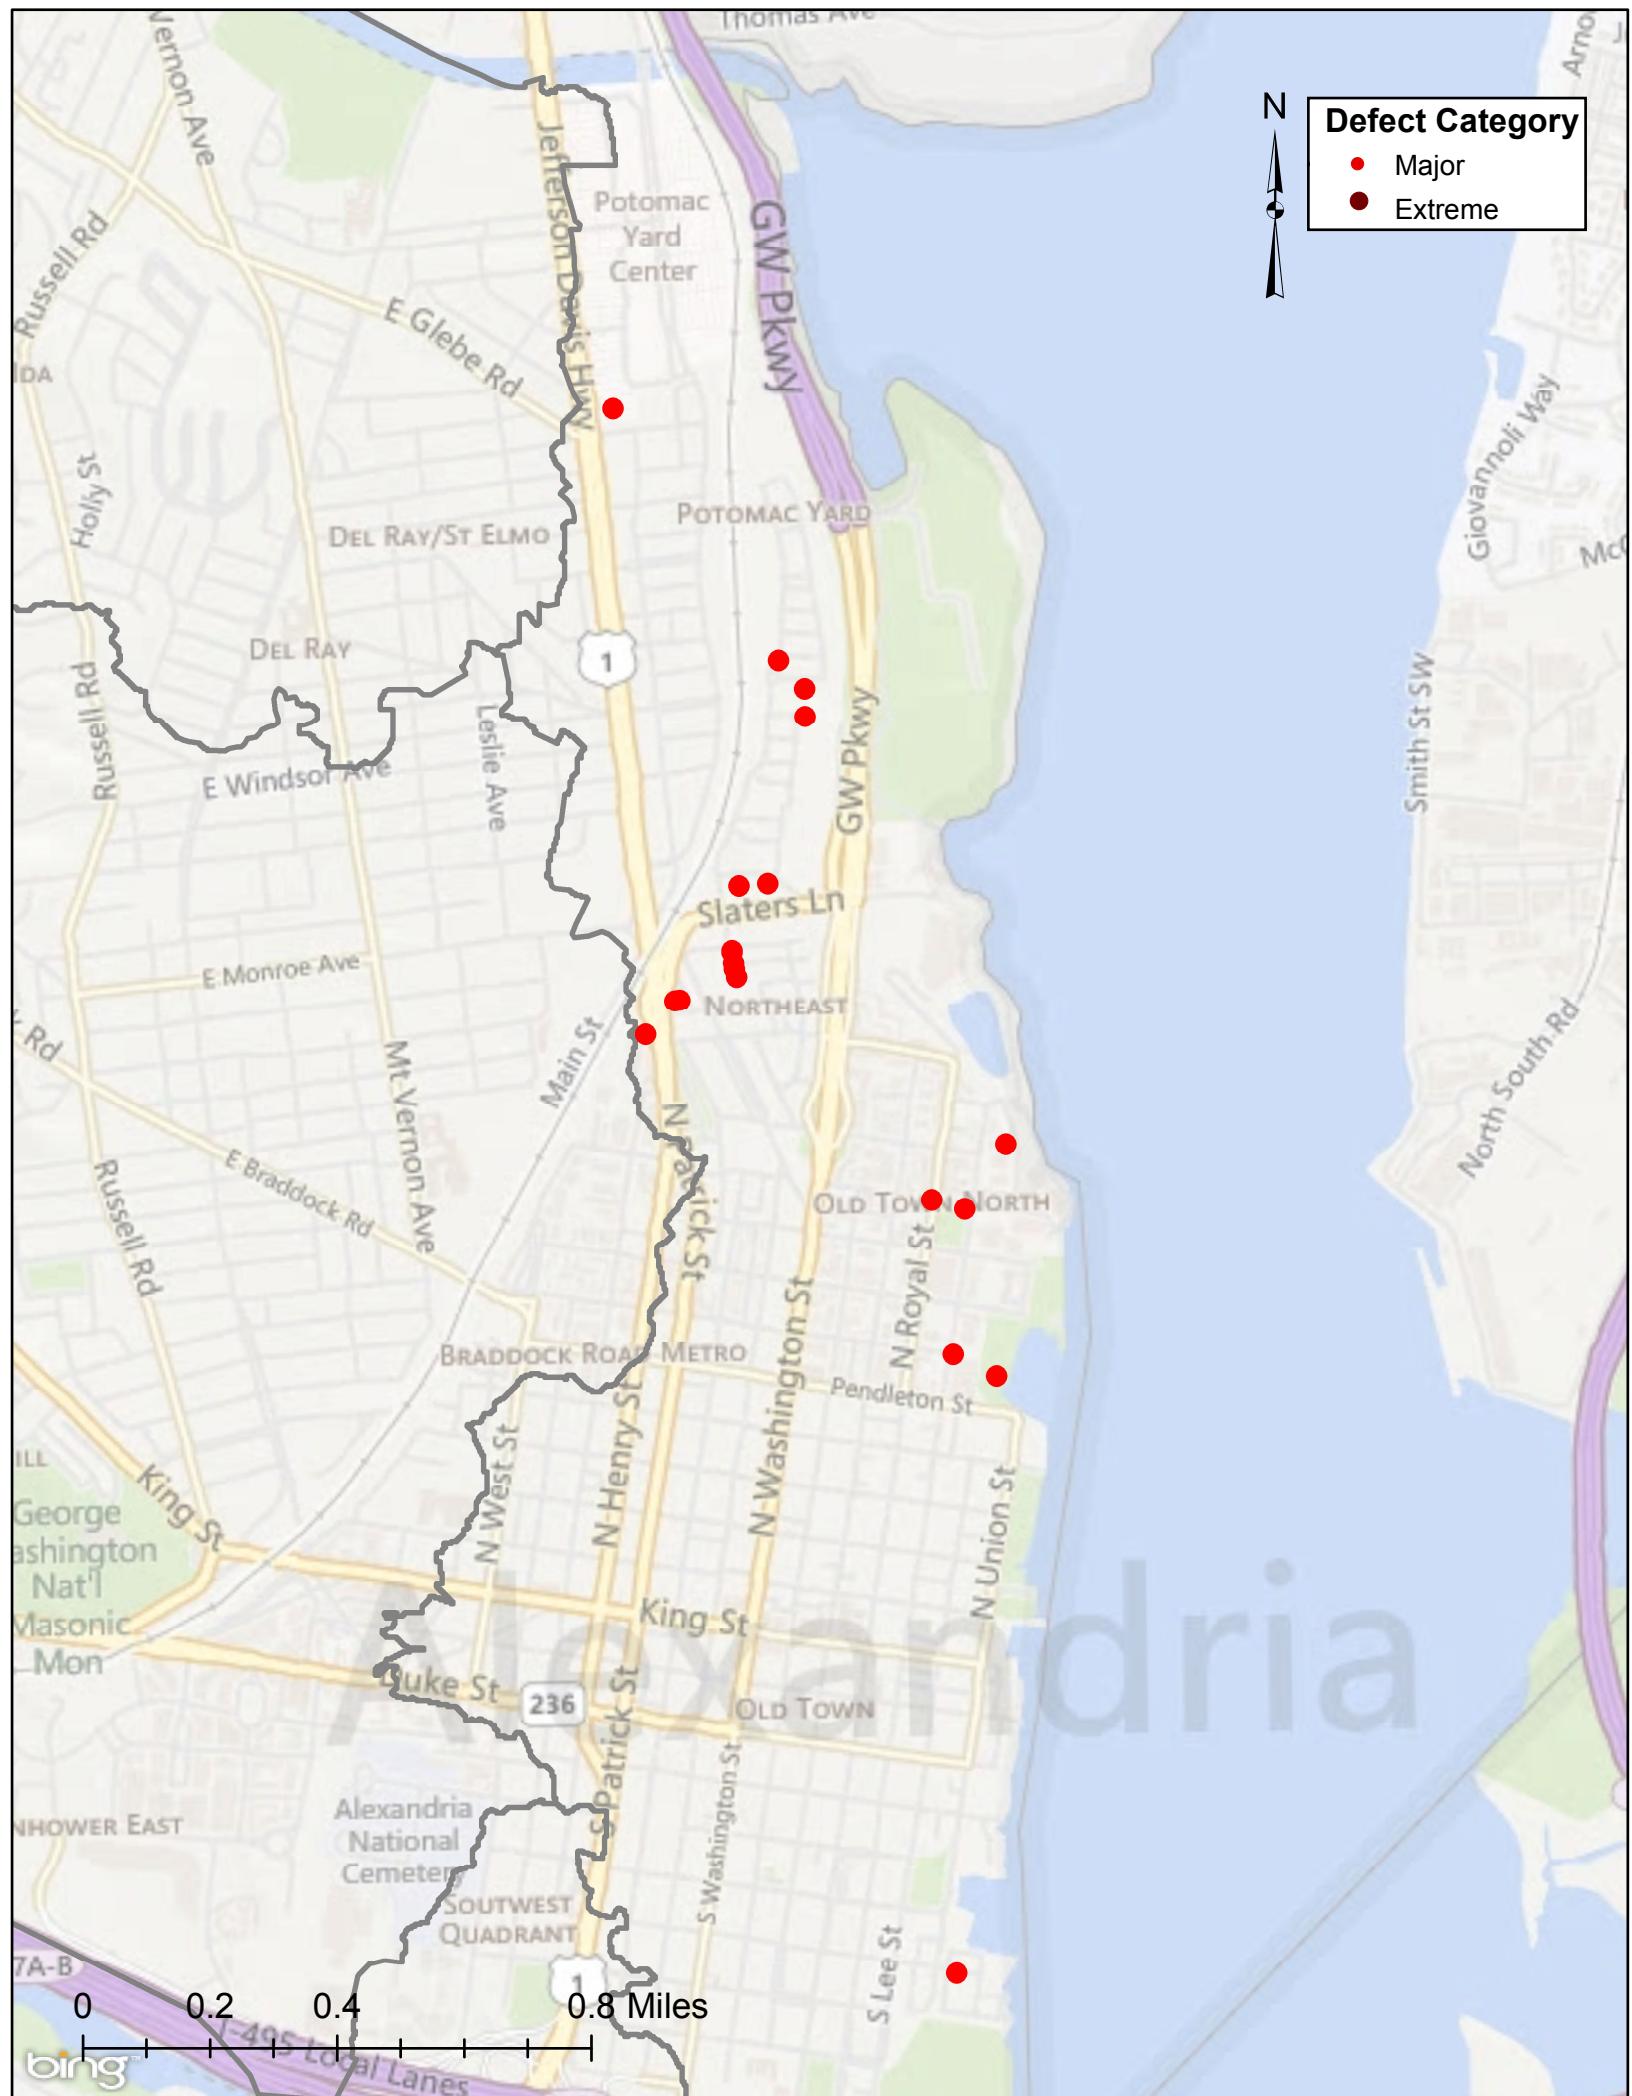
Figure 3 displays the location of the structures classified with major damage only. No extreme defects were observed within Potomac River watershed. In general, the structures with high defect scores are located between Slaters Lane and Pendleton Street, on both sides of George Washington Memorial Parkway. For further detailed condition assessment, the inspection results of the structures were broken down by structure component. Table 2 lists the number of observed defects by component and severity. Note that the table shows a count of the number of defects found in each component and their respective severity across all structures, not the number of inspections performed. Multiple defects may be found in a single component of a structure.

Figure 3. Location of Storm Structures in the "Major" and "Extreme" Categories (Color coded by Severity of Defects).

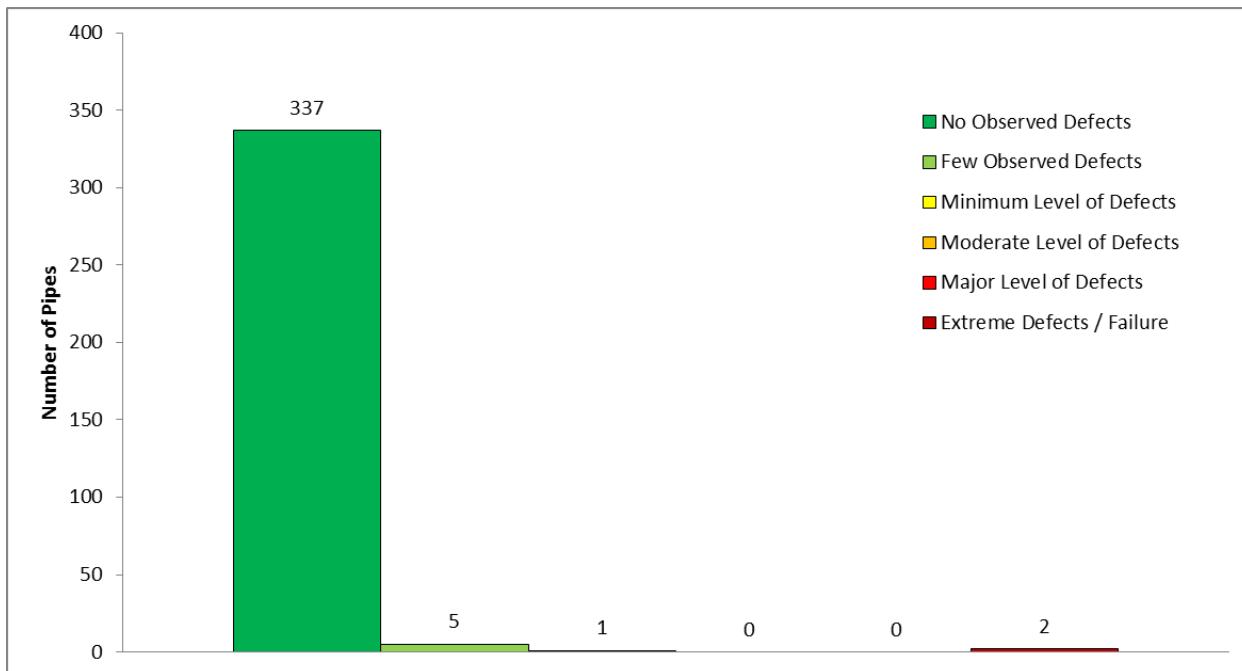
In total, 345 storm sewer pipe segments were inspected in the Potomac River watershed. Figure 12 shows the number of pipe segments within each defect category. Figure 13 shows a map of the location of each inspected pipeline, color coded by the defect categories described above. In total, eight (8) defects were observed in the inspected Potomac River watershed pipes. The average condition score was fewer than 1 ("Few" defect category). Inspection results showed that the pipe segments were observed to be in generally good condition, with no defect observed in 98% of the pipes.

Figure 12. Pipe Lamping Inspections Summary.

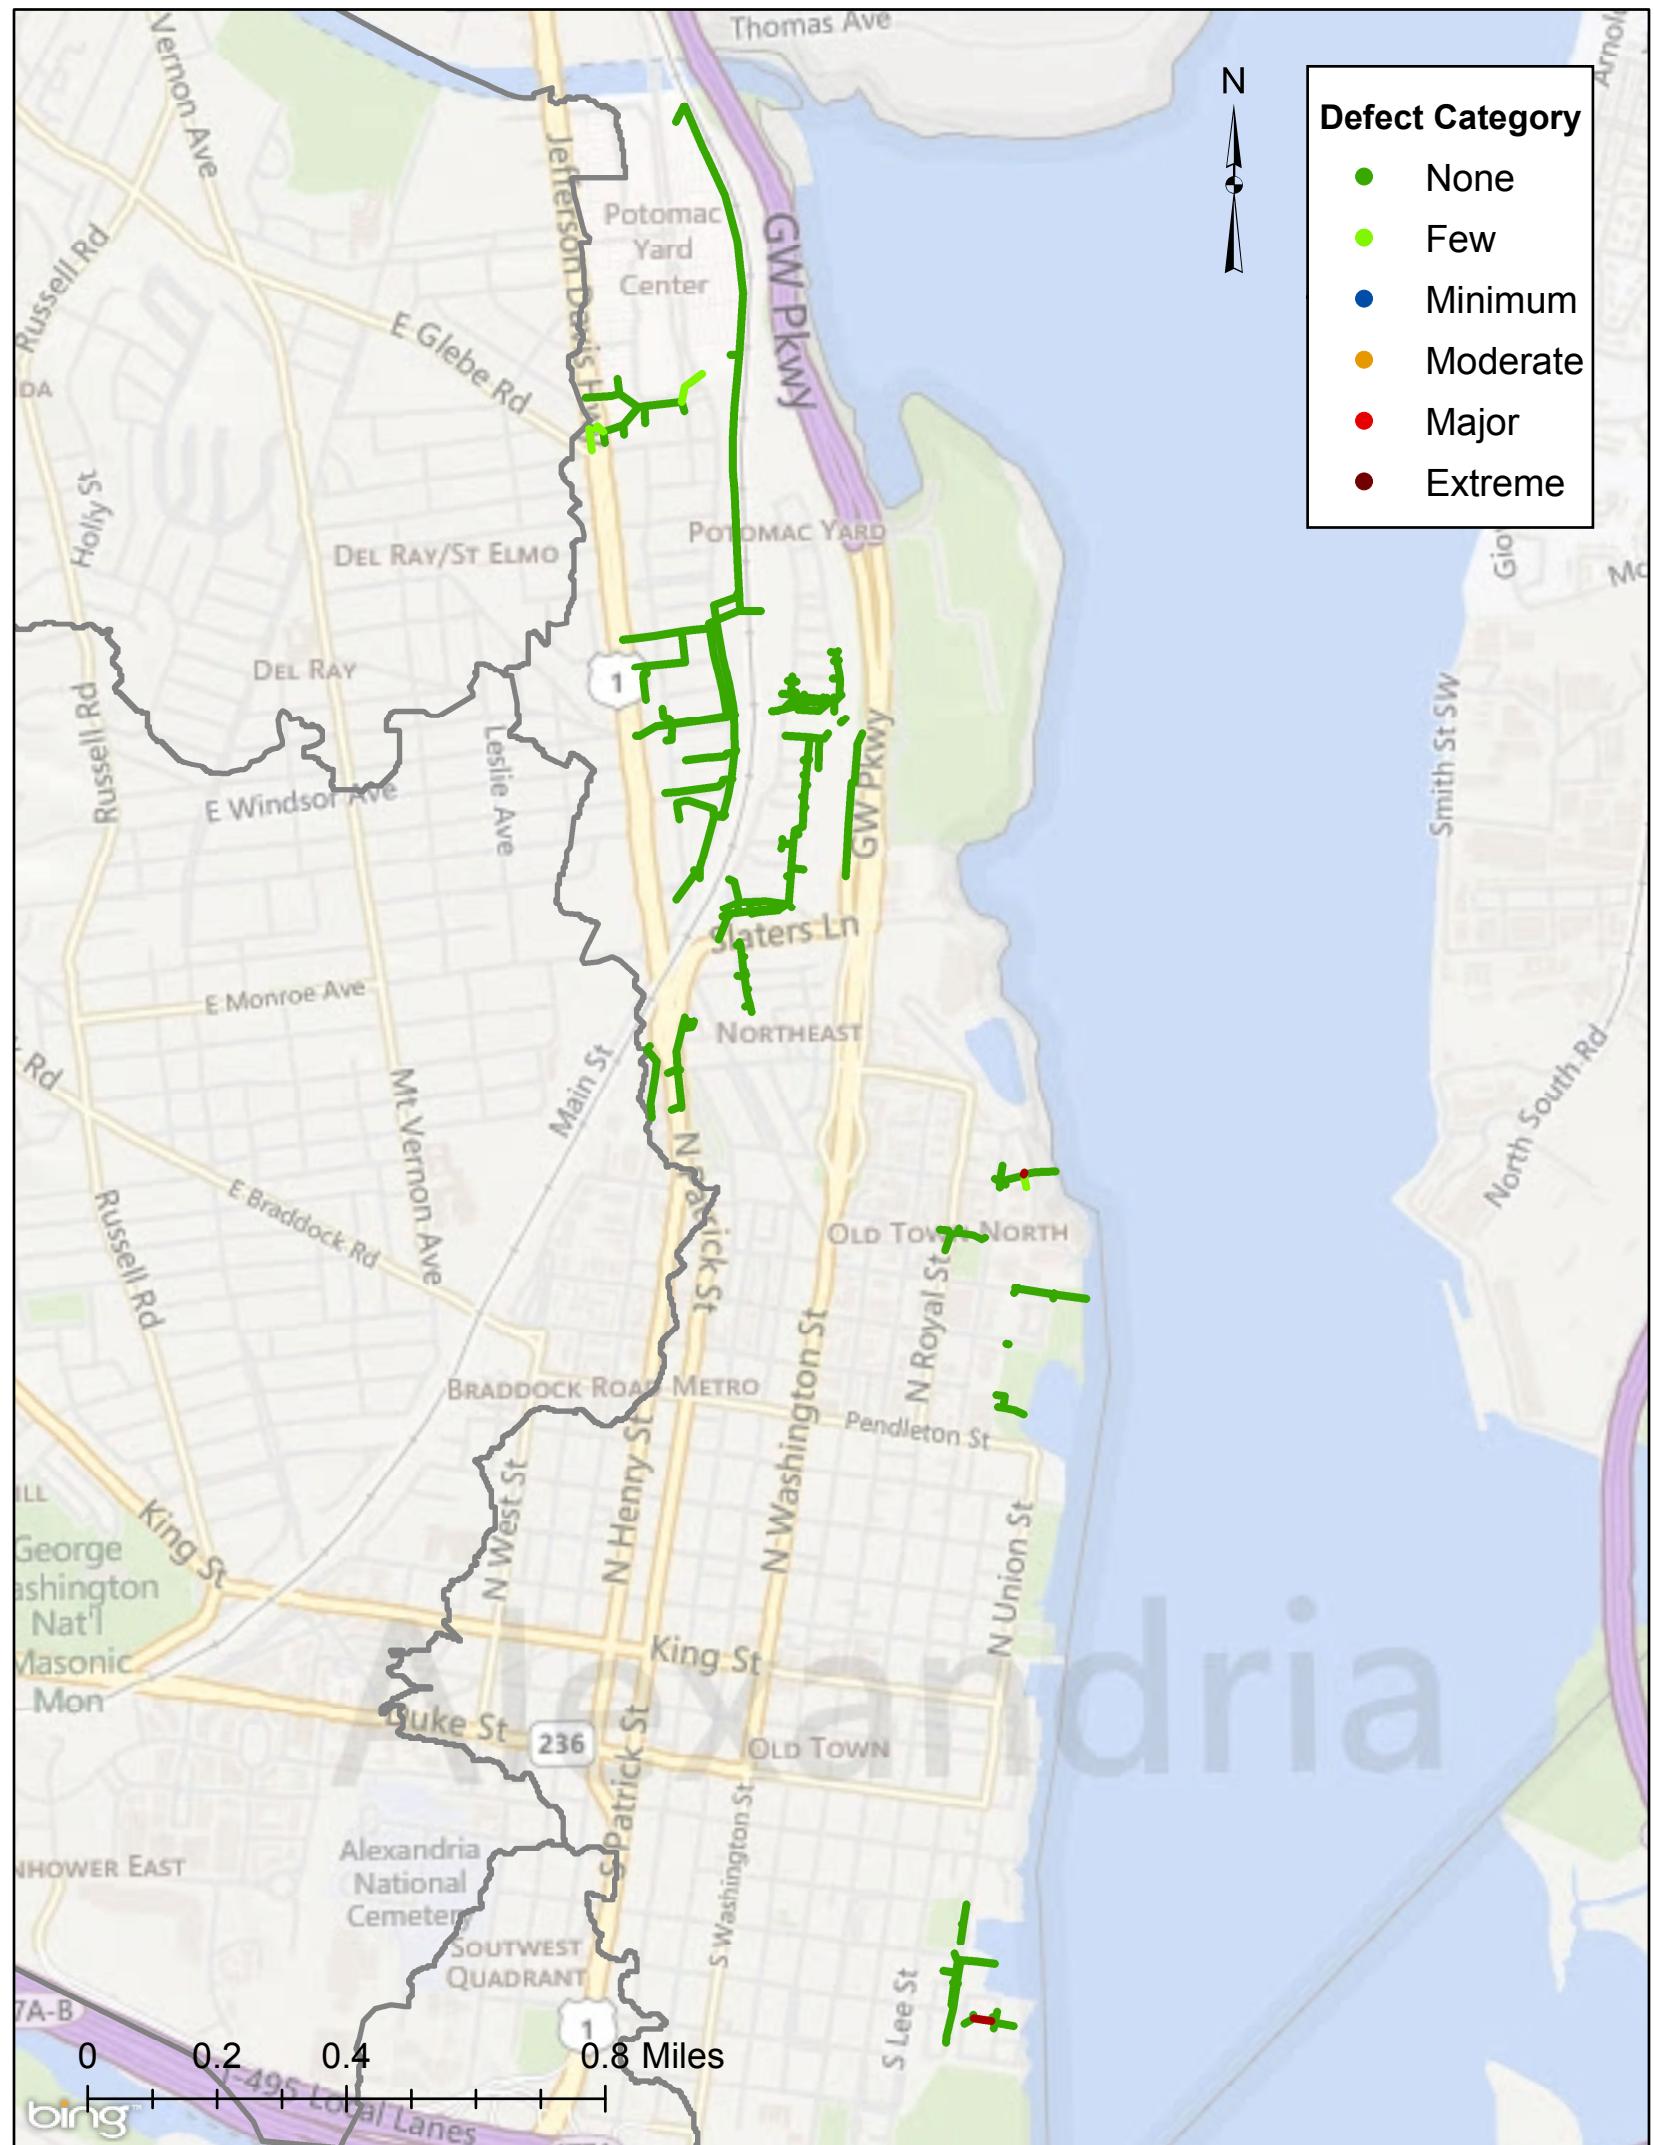
Figure 13. Overall Condition of Storm Pipelines (Color coded by Severity of Defects).
